Manhole Inspection Summary

Manhole # S29UU1009MH

Insp Date: **1/15/07 2:59 PM**

Location Address: **5014 GREENLEAF RD**

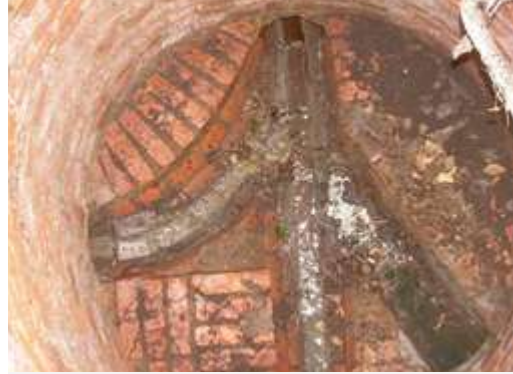
Top View

Bench and Channel debris.

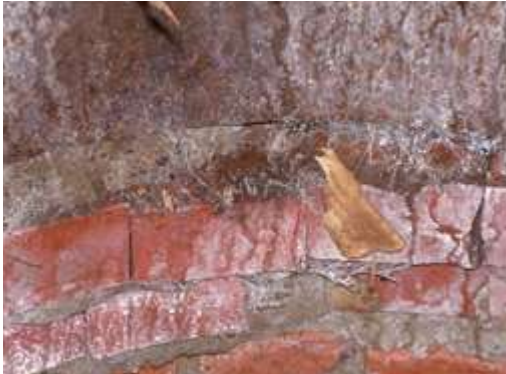
Defect

Adjustment deterioration, root intrusion and infiltration. Corbel root intrusion and infiltration.

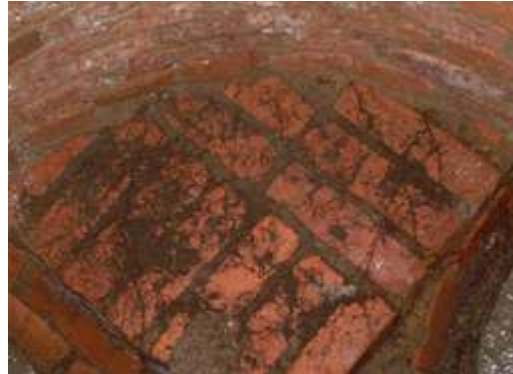
Defect

Bench root intrusion.

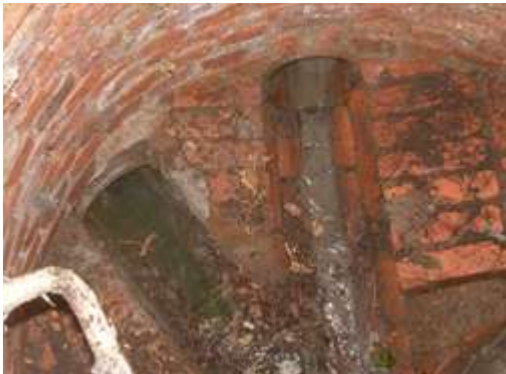
Defect

Channel and Bench root intrusion.

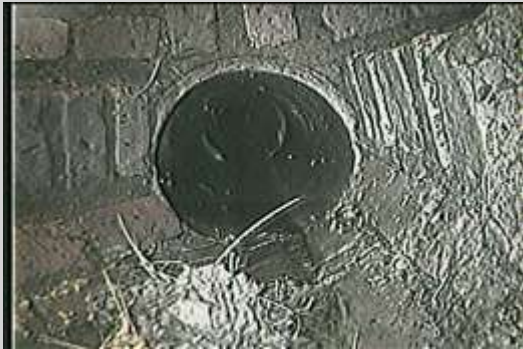
8 in. Circular Gravity Sewer Pipe Out @ 12 O'Clock

Infiltration: **Evidence** Pipe Seal Cond: **Unknown**

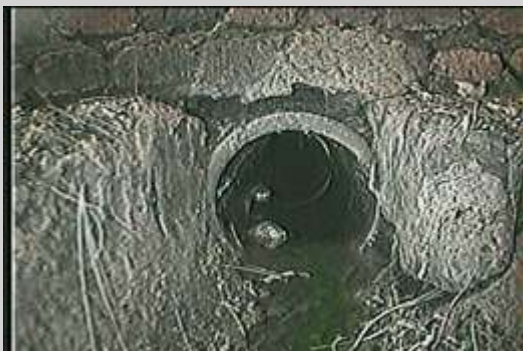
8 in. Circular Gravity Sewer Pipe In @ 4 O'Clock

Barrel deterioration and infiltration. Channel deterioration. Bench and Channel root intrusion.

Infiltration: **Evidence** Pipe Seal Cond: **Broken**

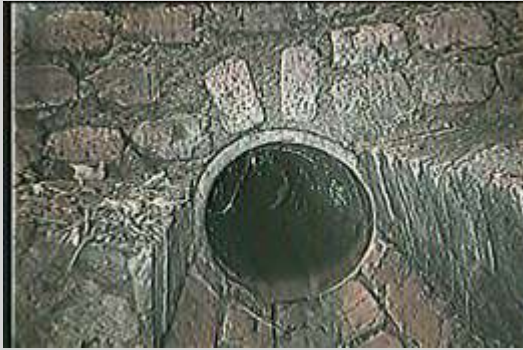
Pipe In @ 6 O'Clock

Infiltration: **Evidence** Pipe Seal Cond: **Unknown**

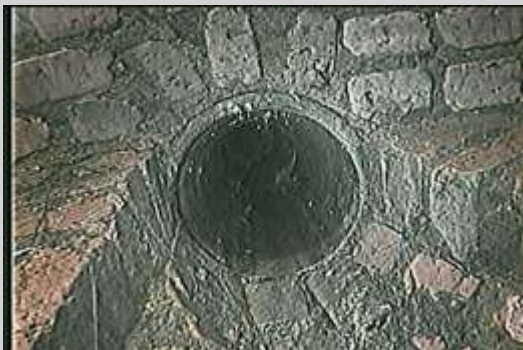
Pipe In @ 9 O'Clock

Infiltration: **Evidence** Pipe Seal Cond: **Unknown**
